IMPACT DAMAGE ON TITANIUM LEADING EDGES FROM
SMALL HARD OBJECTS

University of Dayton Research Institute
300 College Park Avenue
Dayton, Ohio 45469

TECHNICAL REPORT AFML-TR-78-173

Interim Report for the period July 1976 to October 1977

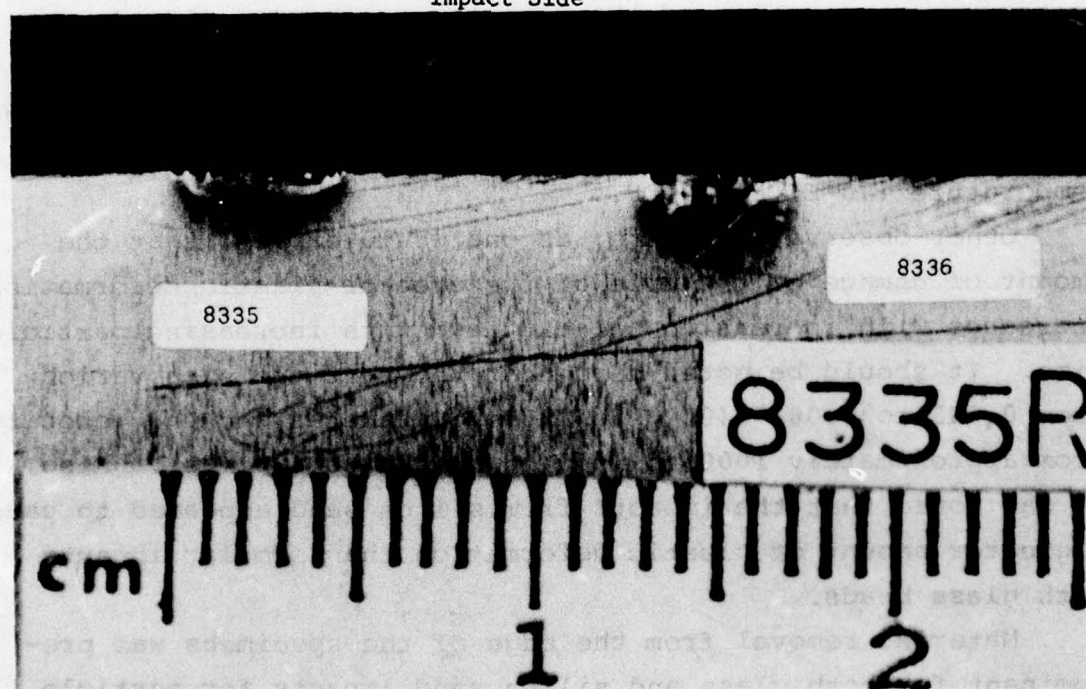
Figure 6. Photographs of damage due to glass bead impacts at 30° (Shots 8335 and 8336).

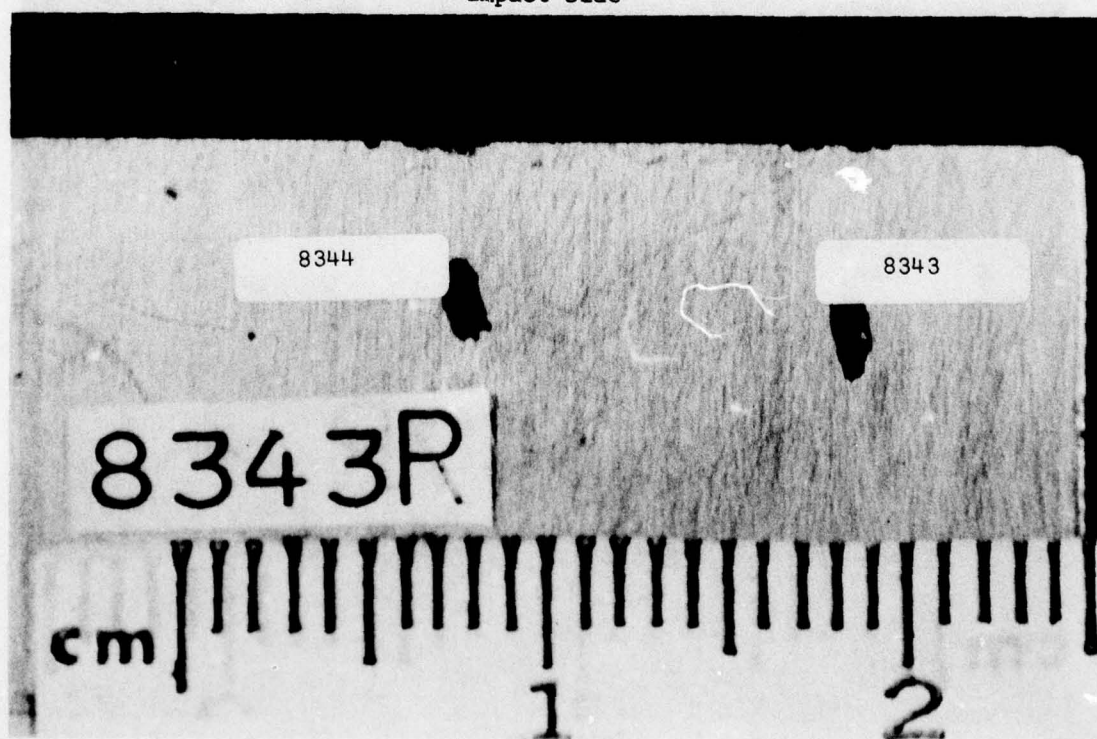
Two other facts were evident from this first series of tests upon observation of the impacted specimens. There appeared to be no observable difference in the induced damage under the conditions noted when (a) the impact angle was changed from 30° to 10° and, (b) the temperature was raised from room temperature (70°F) to 250°F.

Figure 7. Photographs of damage due to glass bead impacts at 10° (Shots 8343 and 8344).

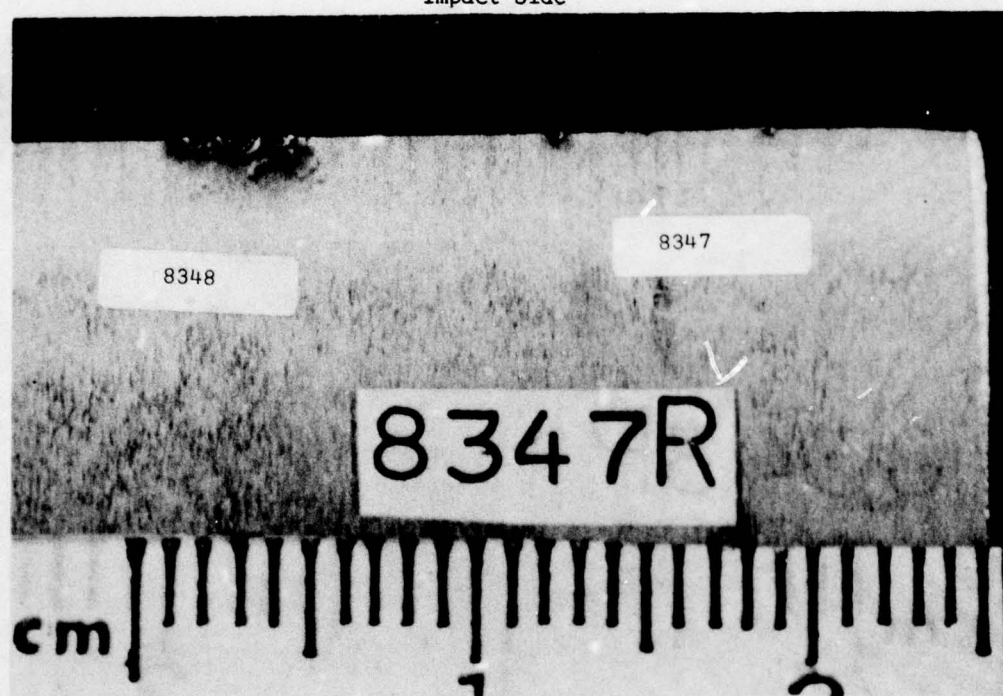
Figure 8. Photographs of damage due to glass bead impacts at 30° and 250°F (Shots 8347 and 8348).

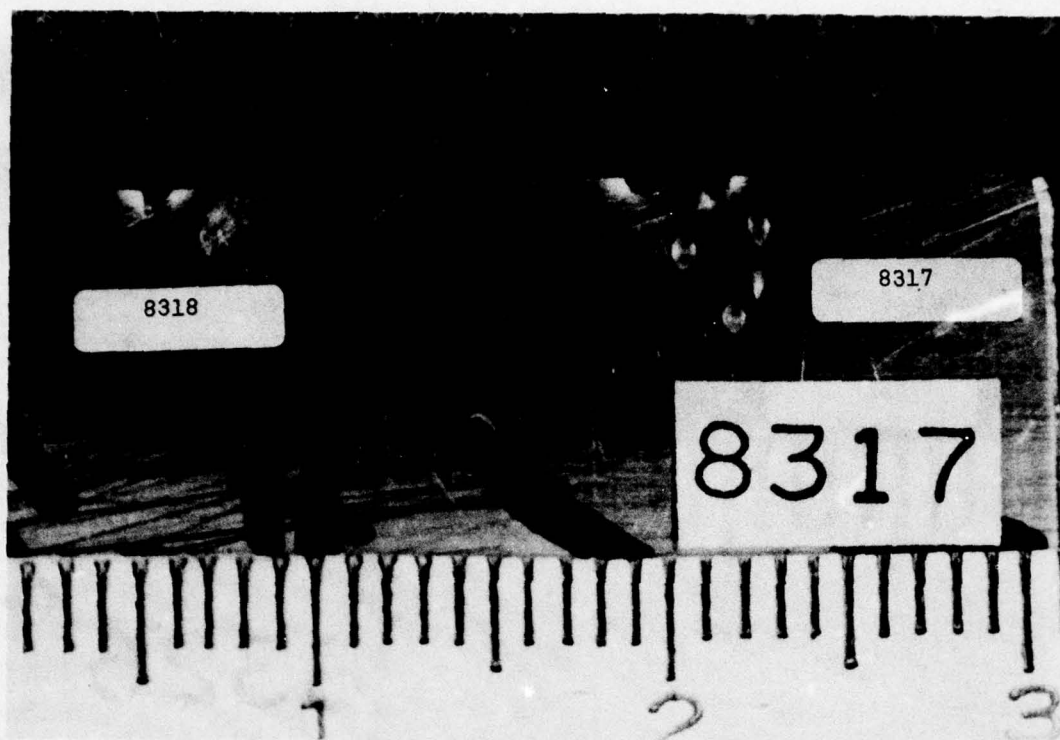
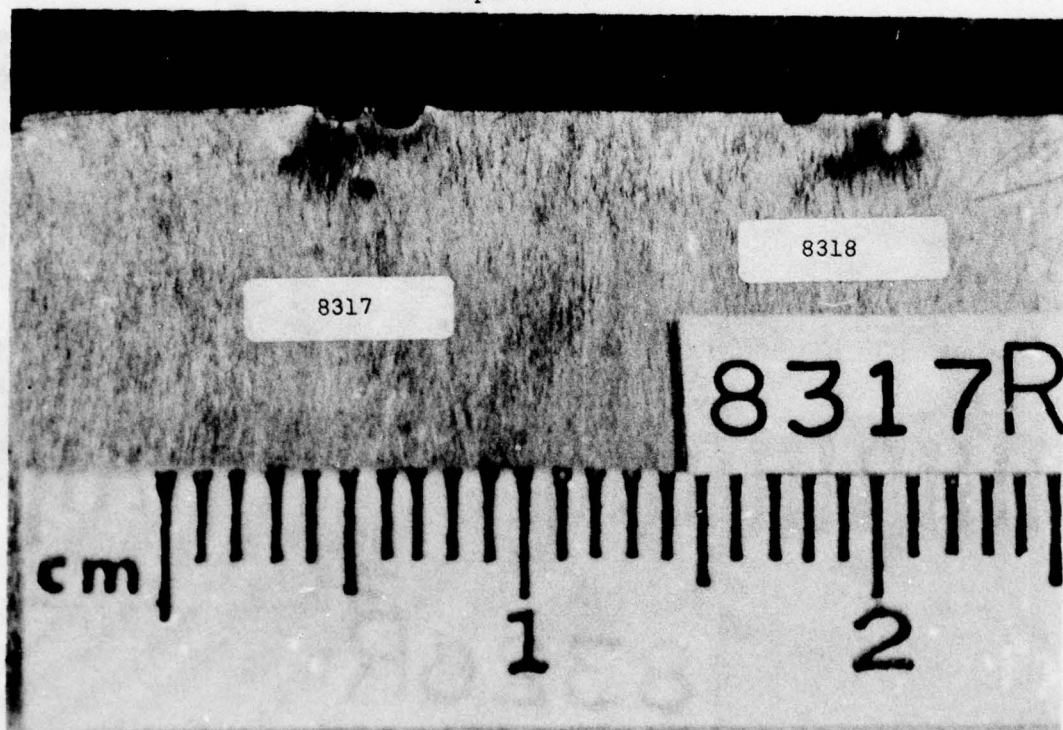
Figure 9. Photographs of damage due to Pyrex bead impacts at 30° (Shots 8317 and 8318).

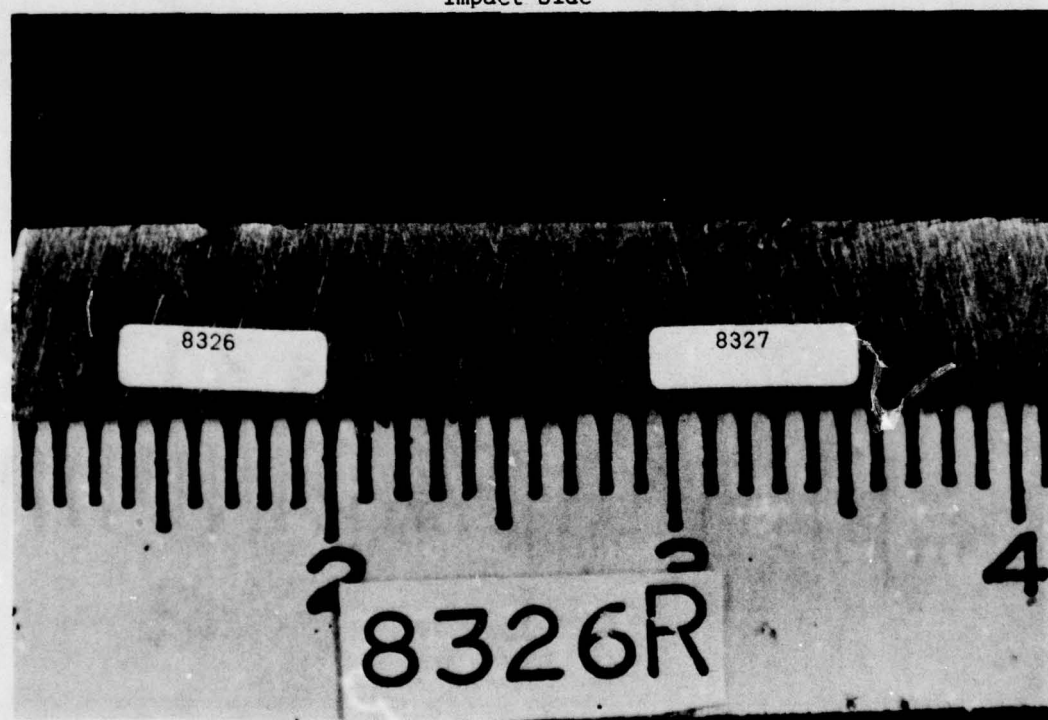
Several things were observed from the results of this series of tests. First, observations of the post-test tapered-edge specimens indicated that silica sand impacts caused more severe damage than glass beads, probably due to their generally irregular shape. Second, impacts by glass beads less than 0.020" (0.51 mm) produced very little damage on the specimen surface. These very small particle impacts generated a peened or pitted surface on the tapered edge of the specimen without material loss. At higher velocities (1500 ft/s (458 m/s) a very small amount of plastic deformation could be observed. It was concluded that impacts of particles under 0.020" (0.51 mm) size does not appear to be a threat to blades of titanium in the velocity range up to 1500 ft/s (458 m/s).

Figure 10. Photographs of damage due to silica sand impacts at 30° (Shots 8326 and 8327).

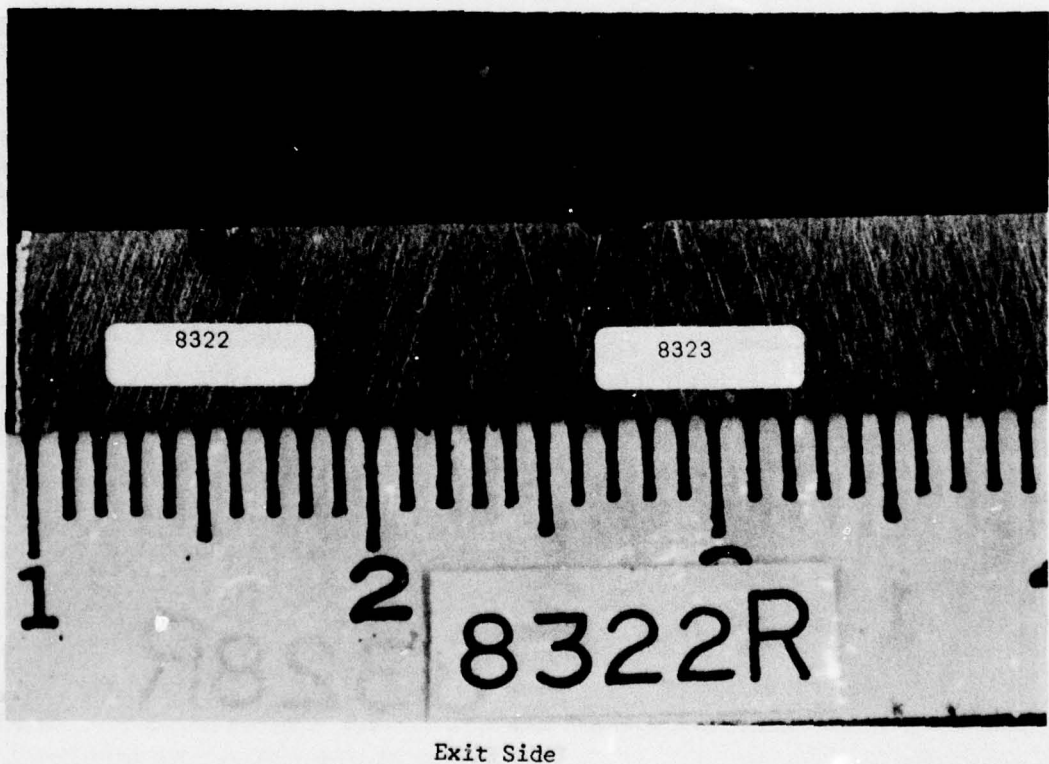
Figure 11. Photographs of damage to silica sand impacts at 30° (Shots 8322 and 8323).

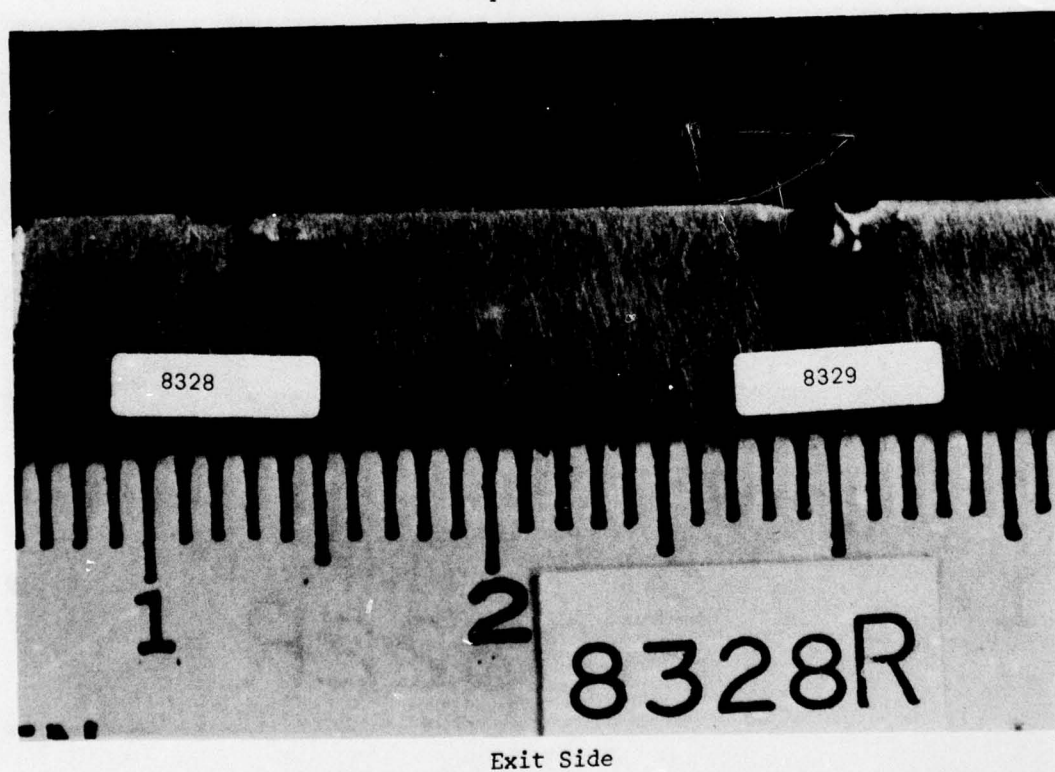
Figure 12. Photographs of damage due to silica sand impacts at 30° (Shots 8328 and 8329).

Note that the shape of the holes or material removed approximates the diameter or portion of particle impacting the edge of the test specimens. For instance, if the trajectory of a particle was such that only a small portion of the particle impacted the specimen edge, only a small amount of material was removed and the shape of the hole was similar to the impacting portion of the particle. If a particle had a trajectory such that half of the particle impacted the specimen edge, the resulting perforation was semicircular in shape.

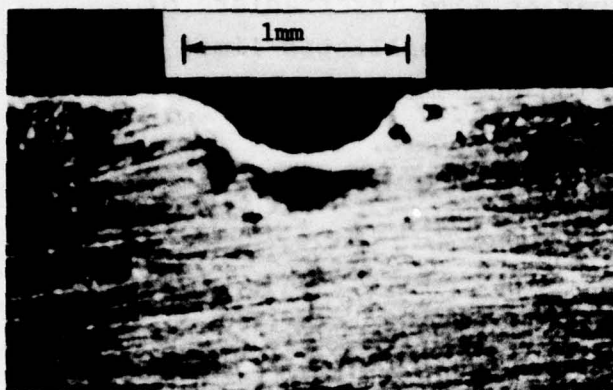
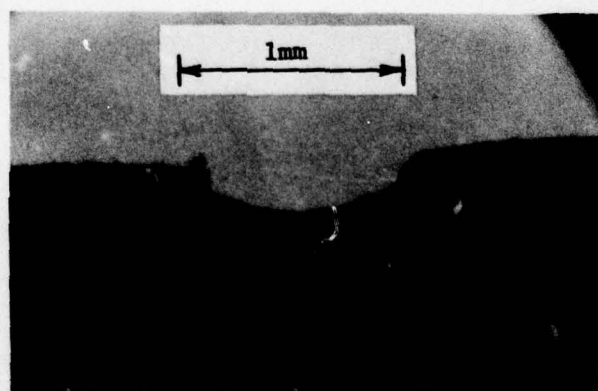
Figure 18. Photographs of several shots showing different types of damage.

this shot was, in any case, three times the dimensions of that in Shots 8368 and 8444. Shots 8433, 8434, and 8432 all represent impacts of the largest projectile 0.125" (3.22 mm) at approximately 800 ft/s (240 m/s). Note that the worst case of damage, Shot 8432, represented a situation where the material first bulged and then apparently ripped from the extensive local deformation. The fatigue crack initiated at the rip in this case.

From the results of this series of tests, it was concluded that the extent of damage depended primarily on the type of damage and appeared to be relatively independent of size. The least severe damage for impacted leading edges was a clean perforation with complete material removal. The next worse case was that where the leading edge curled back extensively or bulged. Finally, the worst case was where the curl back or bulge initiated a rip along the leading edge from which the fatigue crack could propagate. For a given projectile size and leading edge geometry, the test data indicated that perforation

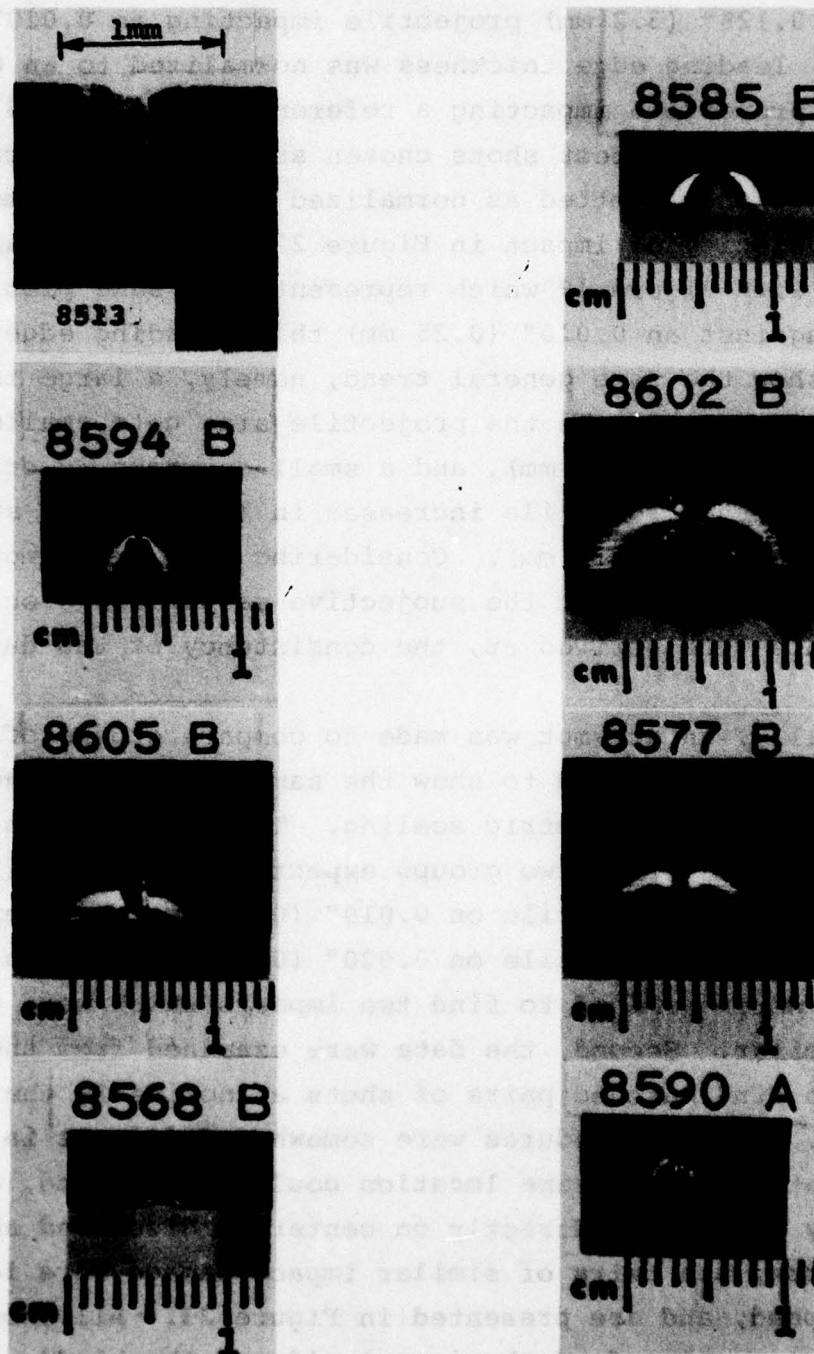
Figure 21. Photographs of typical leading edge damage as seen from rear side.

identification of specimens was subjective. Figure 21 shows rear side photos of the seven specimens selected as well as previous shot 8513 on an 0.010" (0.25 mm) thick specimen.

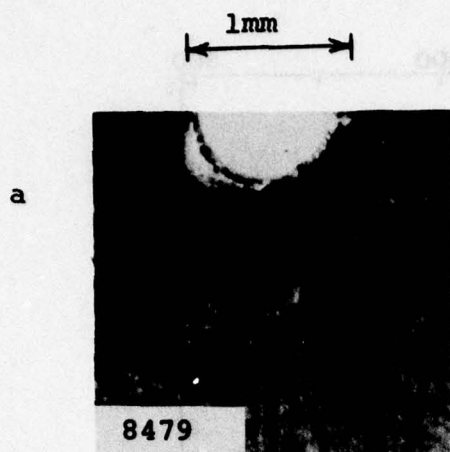
Shots 8479 and 8597, Figure 23a, are examples of perforation where material removal has occurred. These two points, plotted in Figure 24, come out to the right or along the curve or scatter band representing the critical velocity points. Both

shots represent damage typical of that which occurs above the critical velocity. The slightly more jagged surface of the perforation in Shot 8597, occurring at the lower of the two velocities being compared, indicates that this point is close to critical velocity as can be seen from Figure 24.

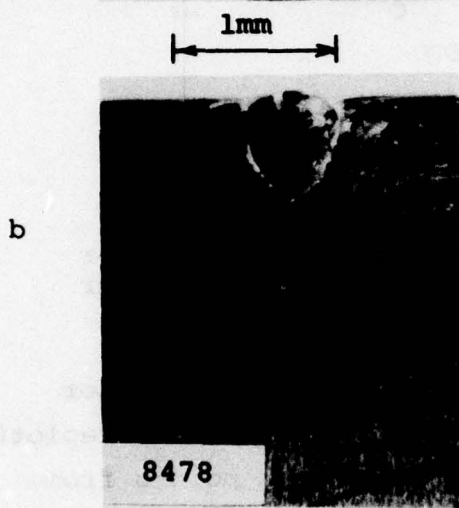
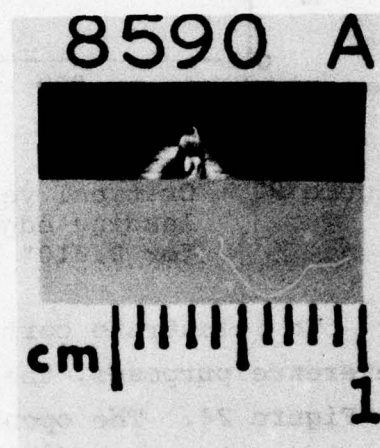
Shots 8478 and 8590, Figure 23b, occur at velocities close to one another. The damage in both cases looks similar, although in Shot 8590 the leading edge has started to tear. This was one of the shots characterized as at critical velocity, in Figures 22 and 24. Shot 8478 occurs at a slightly lower velocity and shows a dent without a tear. This would be considered to be slightly below critical velocity and appears as such in Figure 24.

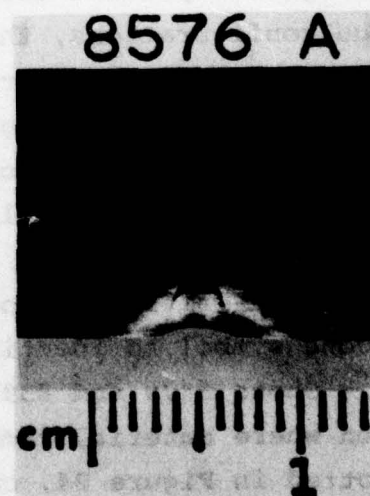
Shots 8488 and 8576, Figure 23c, both show very similar damage involving severe denting but no tearing of the leading edge. The velocities of these shots are close to one another and are considered to be slightly below critical. These points, plotted in Figure 24, fall within or to the left of the scatter

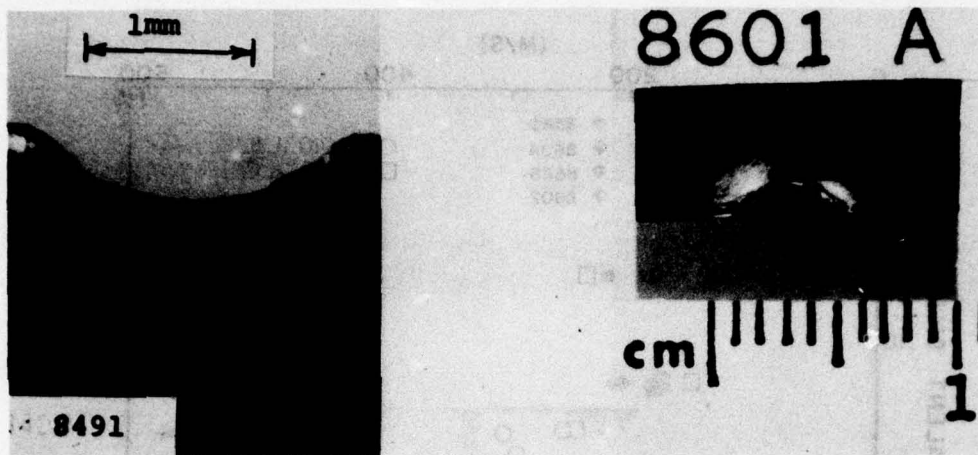
d

Shots 8491 and 8601, Figure 23d, are a pair of shots showing very similar damage in the form of complete perforation with material removal. These points would both be expected to fall above the critical velocity. Note, however, the great difference in velocities. Although, as expected, Shot 8491 is well to the right of the critical velocity scatter band in Figure 24, Shot 8601 falls within the band. Shot 8601 is a good example of the variability in damage which can be expected and the difficulty in determining the critical velocity with a great deal of accuracy from a limited number of shots.

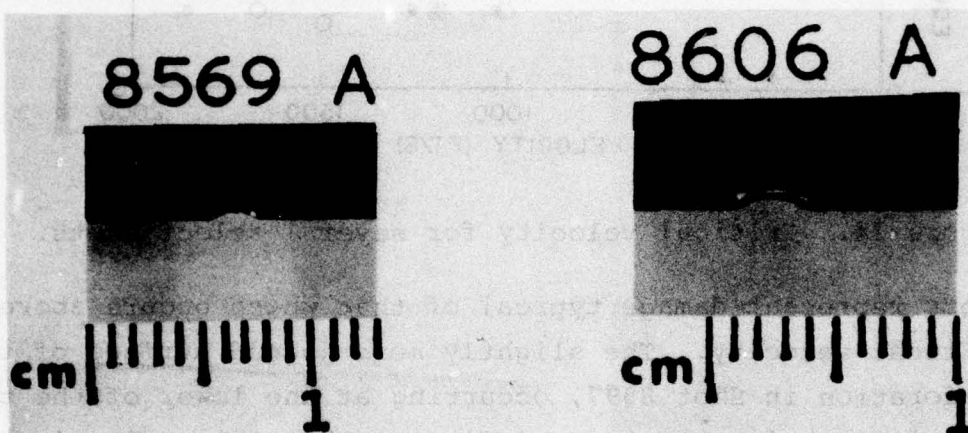
e

Shots 8569 and 8606, Figure 23e, occurred at almost identical velocities and look very similar in type of damage. Both show a crater, indicating complete perforation, although both have rather jagged features along the crater. This indicates that the critical velocity has just been exceeded. The plot of Figure 24 appears to verify this information, the two points falling within or slightly to the right of the critical velocity band.

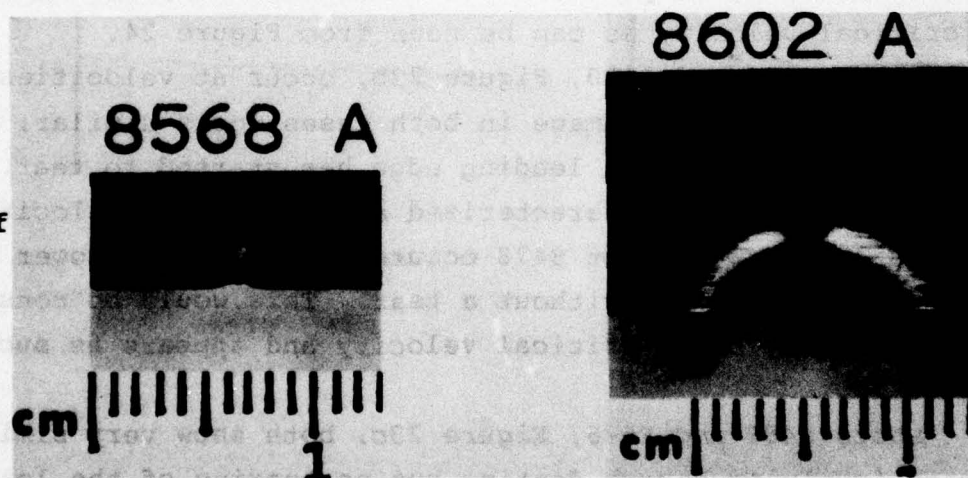
f

Shots 8568 and 8602, Figure 23f, were chosen as representative of damage occurring at the critical velocity. Both show an extensive bulge with a slight tear on the leading edge. Both occurred at almost the same velocity and plot within the critical velocity scatter band. This example illustrates the concept of geometric scaling quite well since the two shots were made on leading edge thicknesses of 0.015" and 0.030" (0.38 and 0.76 mm) with projectiles of 0.125" and 0.250" (3.2 and 6.4 mm) diameter, respectively, and also appear to be consistent with baseline data generated on .010" (0.25 mm) thick leading edges.
